Measure no. V5-CN 65516104-02	Subject G01/G02/G08 - 车门饰件氛围灯发光不同（亮暗不均匀）	
Status date (mm/dd/yy) 4/6/21	Status Accepted	PQM Problem reference 235021910
Date created (mm/dd/yy) 4/6/21	Created by Florian Sturm	Organization V5-CN, CAR
Release date (mm/dd/yy)	Approved by	Dealer release Allow automatic release

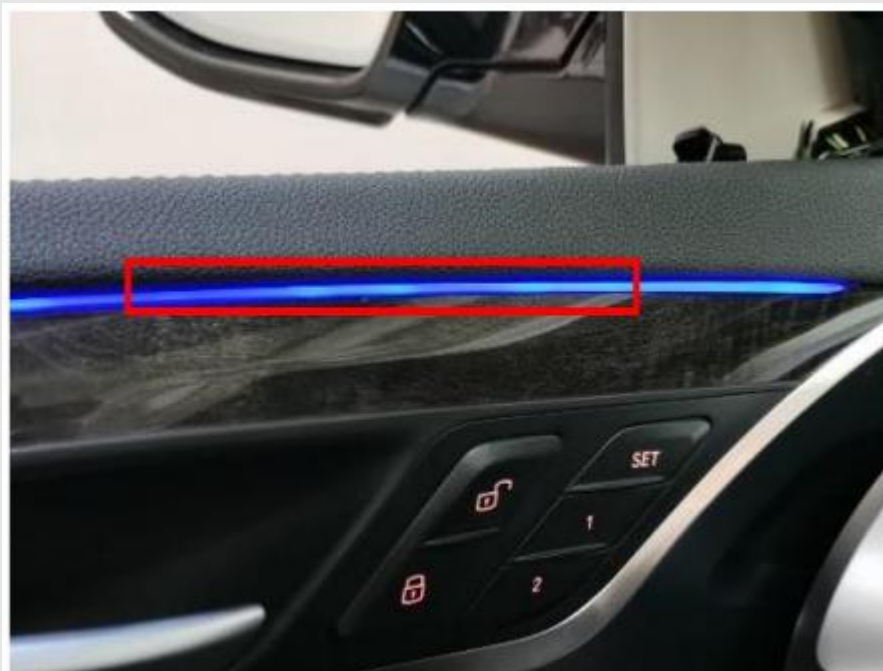
车门饰件中的光导管发光不同（亮暗不均匀）。
详见附件，图 1。

光导管中有水分。

水分可能由于以下情况进入光导管：

- 用过多的水清洗车门饰件
 - 用过多的水清洗侧窗玻璃
(例如：在车窗贴膜时)
 - 阵雨时未关窗
-

1. 拆卸光导管，包括车门饰件盖板（装饰条）。

2. 从车门饰件盖板上拆下光导管。

3. 清洁光导管和透镜（用压缩空气吹洗并用抹布擦干）并重新检查发光情况。
